1.1 Air Disc Brake

1.1.1 Damage to the fixed bearing protective cap spigot

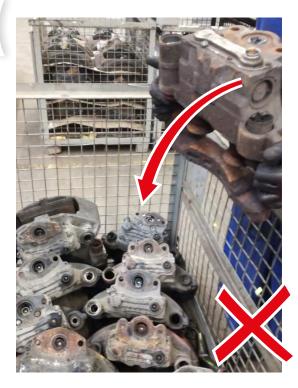
The damage on the calipers is caused by incorrect handling and packing for transportation.

One caliper lies on another caliper (in this case on fixed bearing)

Handle the core with care and where possible use the original box for the core return. If the box is not available then the cores should be packed in layers with spaces between the cores to prevent damage during transportation. On no account should the cores be simply stacked on top of each other.

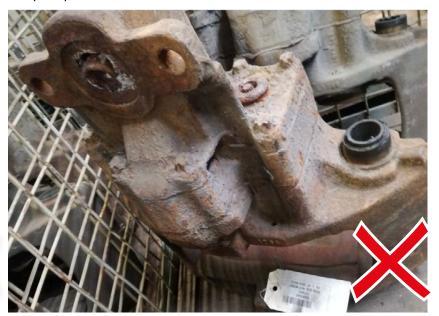
In some cases excessive corrosion is the result of incorrect storage including exposure to cold / wet weather without adequate protection.

Part that may have been stored outside without adequate protection

*Warning!*Do not store outside

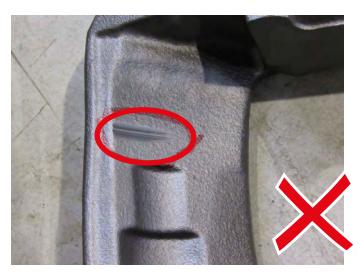
Mechanical damage caused by contact with the brake disc.

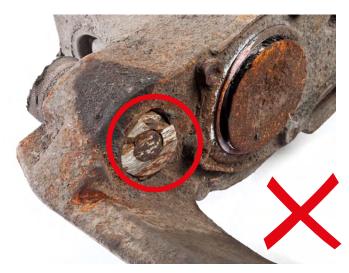
Incorrect disassembly, damage caused by the use of an angle grinder.

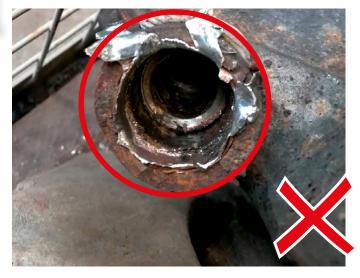
Incorrect disassembly of the guide pin cap

Refer to the appropriate service manual, follow the instructions and use the tooling specified.

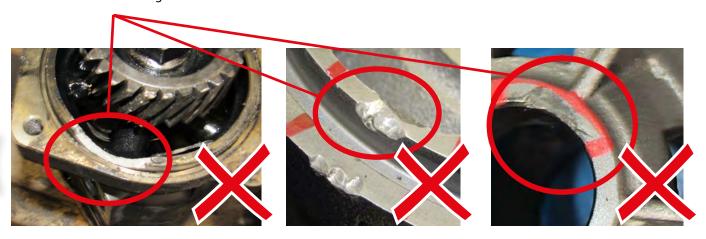
Damage to the mounting flange area can be caused by poor disassembly methods, incorrect handling after removal or poor packaging for transportation.

Damage of the contact and sealing area, the core is not usable for remanufacturing.

For disassembly use the appropriate tools only! Please follow service instructions for disassembly.

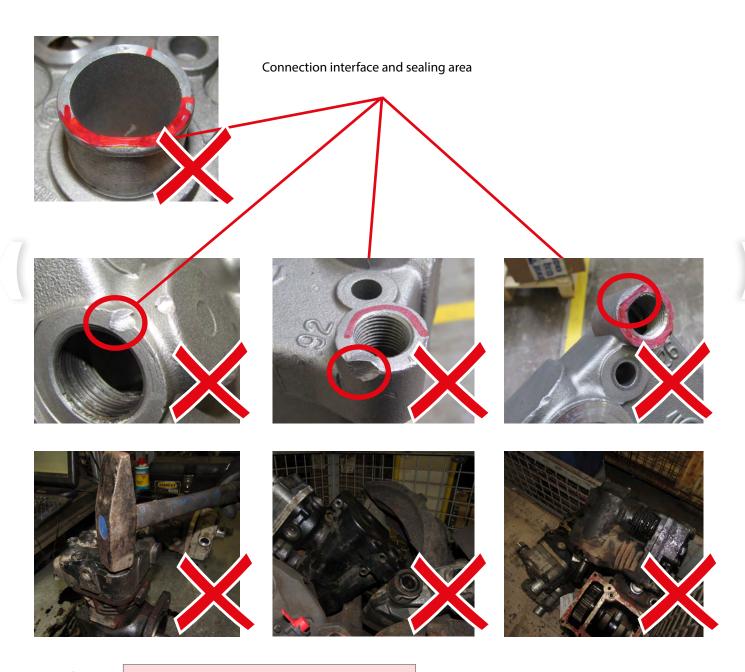
Damage to the ports caused by incorrect disassembly methods, poor handling or poorly packed for transportation

We cannot repair this type of damage to the ports, resulting in the core being unusable for remanufacturing.

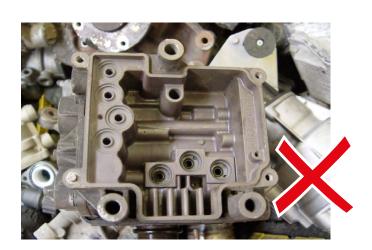
Damage in the electronics area is not acceptable.

If the core has sign of intervention by 3rd party (repair, service), it's not usable for remanufacturing.

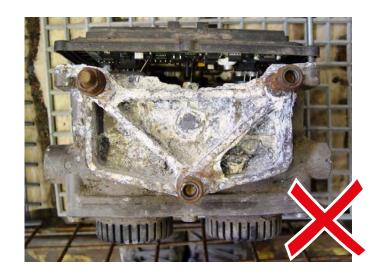
Housing is heavily corroded. Core with corrosion that expose's the electronics is unacceptable.

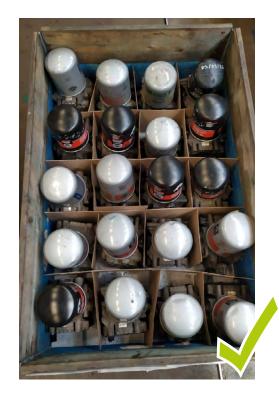
Cardboard spacers

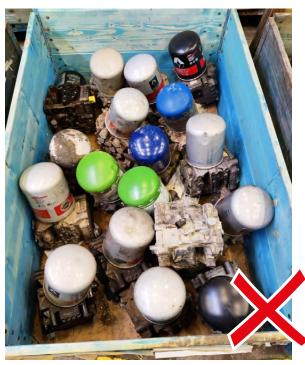
No cardboard spacers

No plugs

Attach the **plug covers** to the ports right after the disassembly from a truck, to prevent any damage during the core return process.

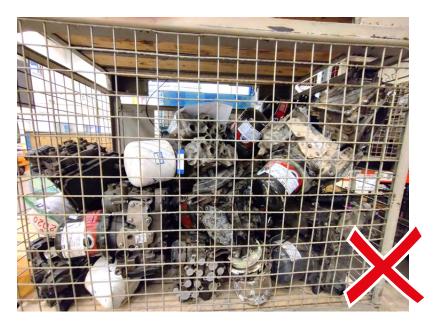
Cores thrown over each other

Handle the core with care and use the (original) packaging for core transport to prevent the damage. (If the box is not available, use layers and spacers for the packaging.)
