NOx Sensor

USER MANUAL

PST-GF30

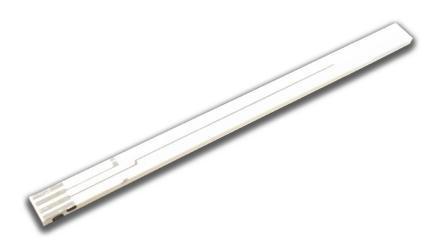
The sensing element is a ceramic chip (see Fig. 1) that consists of a heating circuit, small passage leading into two cavities, oxygen pumping circuit and NOx decomposition circuit.

Figure 1. NOx sensing element (chip)

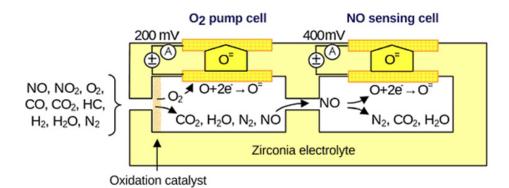
Before operation, the ceramic chip is heated for approximately 1,5 minutes for it to become functional. As the exhaust gas enters the ceramic chip through the small passage (see Fig. 2), at the first cavity all the free oxygen molecules are pumped through the electrolyte and remaining gasses diffuse into the second cavity where NOx molecules are decomposed and the resulting oxygen measured as a small electric current. Additional circuit board (see Fig. 3) is used to convert the measured current to a signal which is compatible with the Engine Control Unit (ECU) communications protocol.

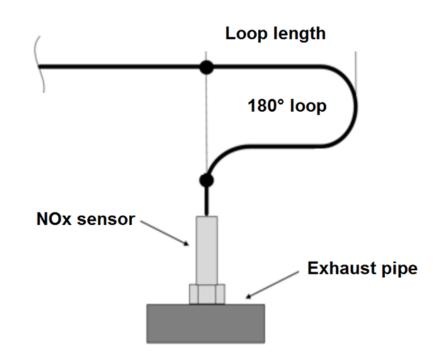
During storage or installation, please make sure that the sensor wires are hanging tension-free. After proper installation the sensor wire should for a 180 degree loop to provide for safe play-distance (see Fig. 4).

Figure 4. Suggested wire handling.

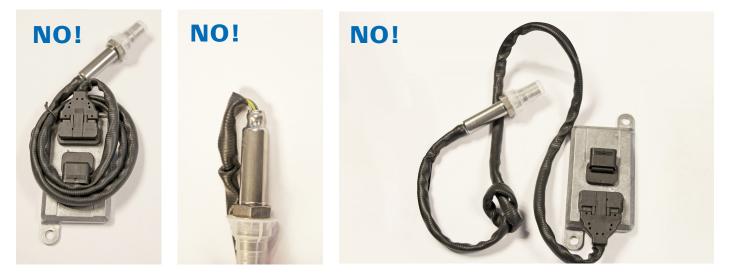
It is likewise prohibited to wind or bend the wire (see Fig. 5).

Figure 5. Inappropriate wire handling.

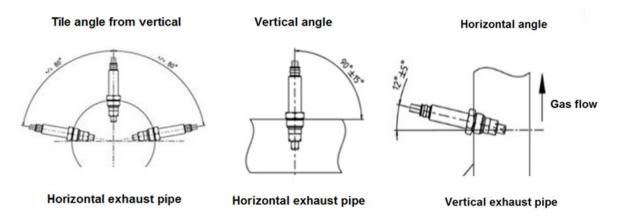
Figure 7. Sensor placement angles.

When choosing a location of a NOx sensor, please also consider the potential for pools of condensate water to form in the exhaust system. Some examples of this issue are illustrated in figures 8 and 9. The sensor location should be chosen such that during operation there is no risk for the condensate water to come in contact with the sensor head. Additional placement suggestions are given in figure 7.

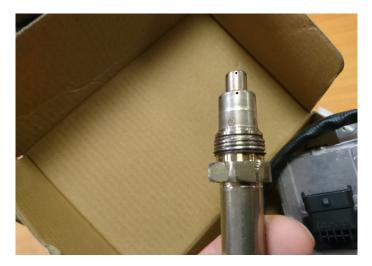
Please make sure that all the issues from troubleshoot section have been repaired before installing Dinex product. If evidence of any of the issues listed under troubleshoot section will be detected during warranty investigation, the claim will be rejected. Likewise, the sensor body and wiring must not bear visible signs of damage in order for the warranty to be valid. If the sensor thread or nut has sustained damage, it is evidence of excessive force that can potentially lead to failure (see Figure 11).

Figure 11. Damaged sensor thread and nut.

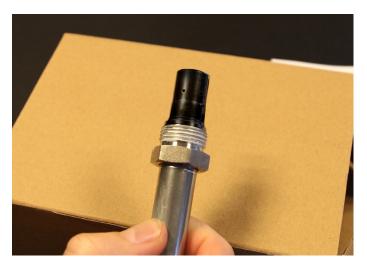
If there are considerable stains of soot/ash on the sensor head (see Figure 12) it is evidence of a damaged DPF or poorly calibrated engine operation. The sensor chip in this case is easily damaged therefore warranty becomes void.

Figure 12. Evidence of excessive soot/ash.

- Excessive soot/ash content in exhaust gas. The sensor head will be black (see figure 9).
- Contaminated exhaust gasses. Engine oil contamination is a common issue indicating worn out engine components.
- Lacking or excessive supply voltage due to short circuit, sudden voltage spikes or external power source.
- Direct contact with condensate during operation.
